DEPARTMENT OF TRANSPORTATION**DIVISION OF ENGINEERING SERVICES**

Quality Assurance and Source Inspection

Contract #: 04-0120F4Cty: SF/ALA Rte: 80 PM: 13.2/13.9File #: 69.28**WELDING INSPECTION REPORT****Resident Engineer:**Pursell, Gary**Address:** 333 Burma Road**City:** Oakland, CA 94607**Report No:** WIR-001248**Date Inspected:** 17-Dec-2007**Project Name:** SAS Superstructure**OSM Arrival Time:** 630**Prime Contractor:** American Bridge/Fluor Enterprises, a JV**OSM Departure Time:** 1530**Contractor:** Zhenhua Port Machinery Company, Ltd (ZPMC), Changxing Island **Location:** Shanghai, China**CWI Name:** Xu Lefeng**CWI Present:** Yes No**Inspected CWI report:** Yes No N/A**Rod Oven in Use:** Yes No N/A**Electrode to specification:** Yes No N/A**Weld Procedures Followed:** Yes No N/A**Qualified Welders:** Yes No N/A**Verified Joint Fit-up:** Yes No N/A**Approved Drawings:** Yes No N/A**Approved WPS:** Yes No N/A**Delayed / Cancelled:** Yes No N/A**Bridge No:** 34-0006**Component:** Tower Mock-up**Summary of Items Observed:**

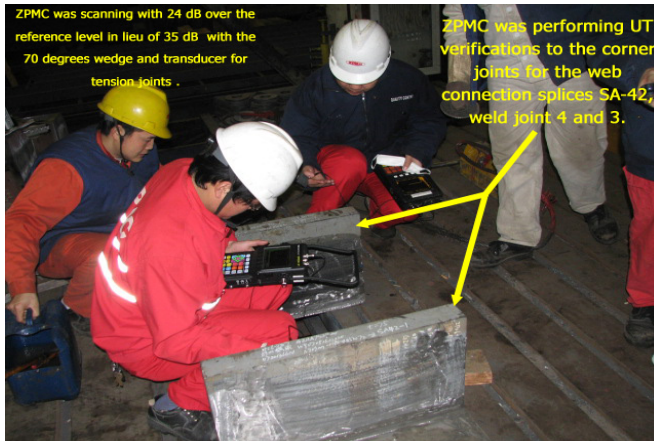
Item Description	WBS	Dwg No.	Status
1 ZPMC UT examination at the connection corner splices (2) SA-42 subassemblies			
The QA inspector witnessed ZPMC approved ultrasonic testing (UT) technicians Li Li Ming and Xue Hai Rong performing UT verifications on the SA-42 subassemblies for the Tower Mock-up 89M at the corner weld joints # 3 and 4 scanning from sides A and B.			
The QA inspector observed that ZPMC UT verifications appeared to be in accordance with the contract documents. However, the QA inspector observed that ZPMC scanned 24 dB over the reference amplitude level in lieu of 35 dB when scanning with 70 degrees transducer as required by AWS D1.5-2002(The QA inspectors had informed this issue to ABF representatives in numerous occasions).

2. ZPMC was not scanning far enough with 70 degrees transducer to evaluate the bottom quarter of the weld (The QA inspector mentioned to Mr. Li Li Ming and ZPMC performed additional rescanning).			
ZPMC found that welds were in compliance with the contract documents.

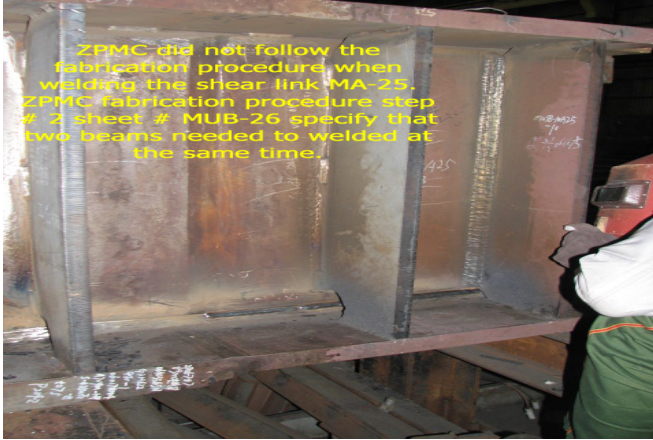
- 6 Shear Links Welding Tower Mock-up 89 M
ZPMC welded the Shear link MA-25 no in accordance with the ZPMC's fabrication procedure for the Tower Mock-up 89 Meters elevation. ZPMC fabrication procedure step # 2, sheet # MUB-26 specify two shear links being welded at the same time. The photograph below shows ZPMC welding only one shear link.
This deviation had been noted on the ZPMC's fabrication procedure.
